P. G. 73-19
Northampton Slave Quarters (Log)
Largo
Site

INVENTORY FORM FOR STATE HISTORIC SITES SURVEY

Northampton Slave Quarters (Log)

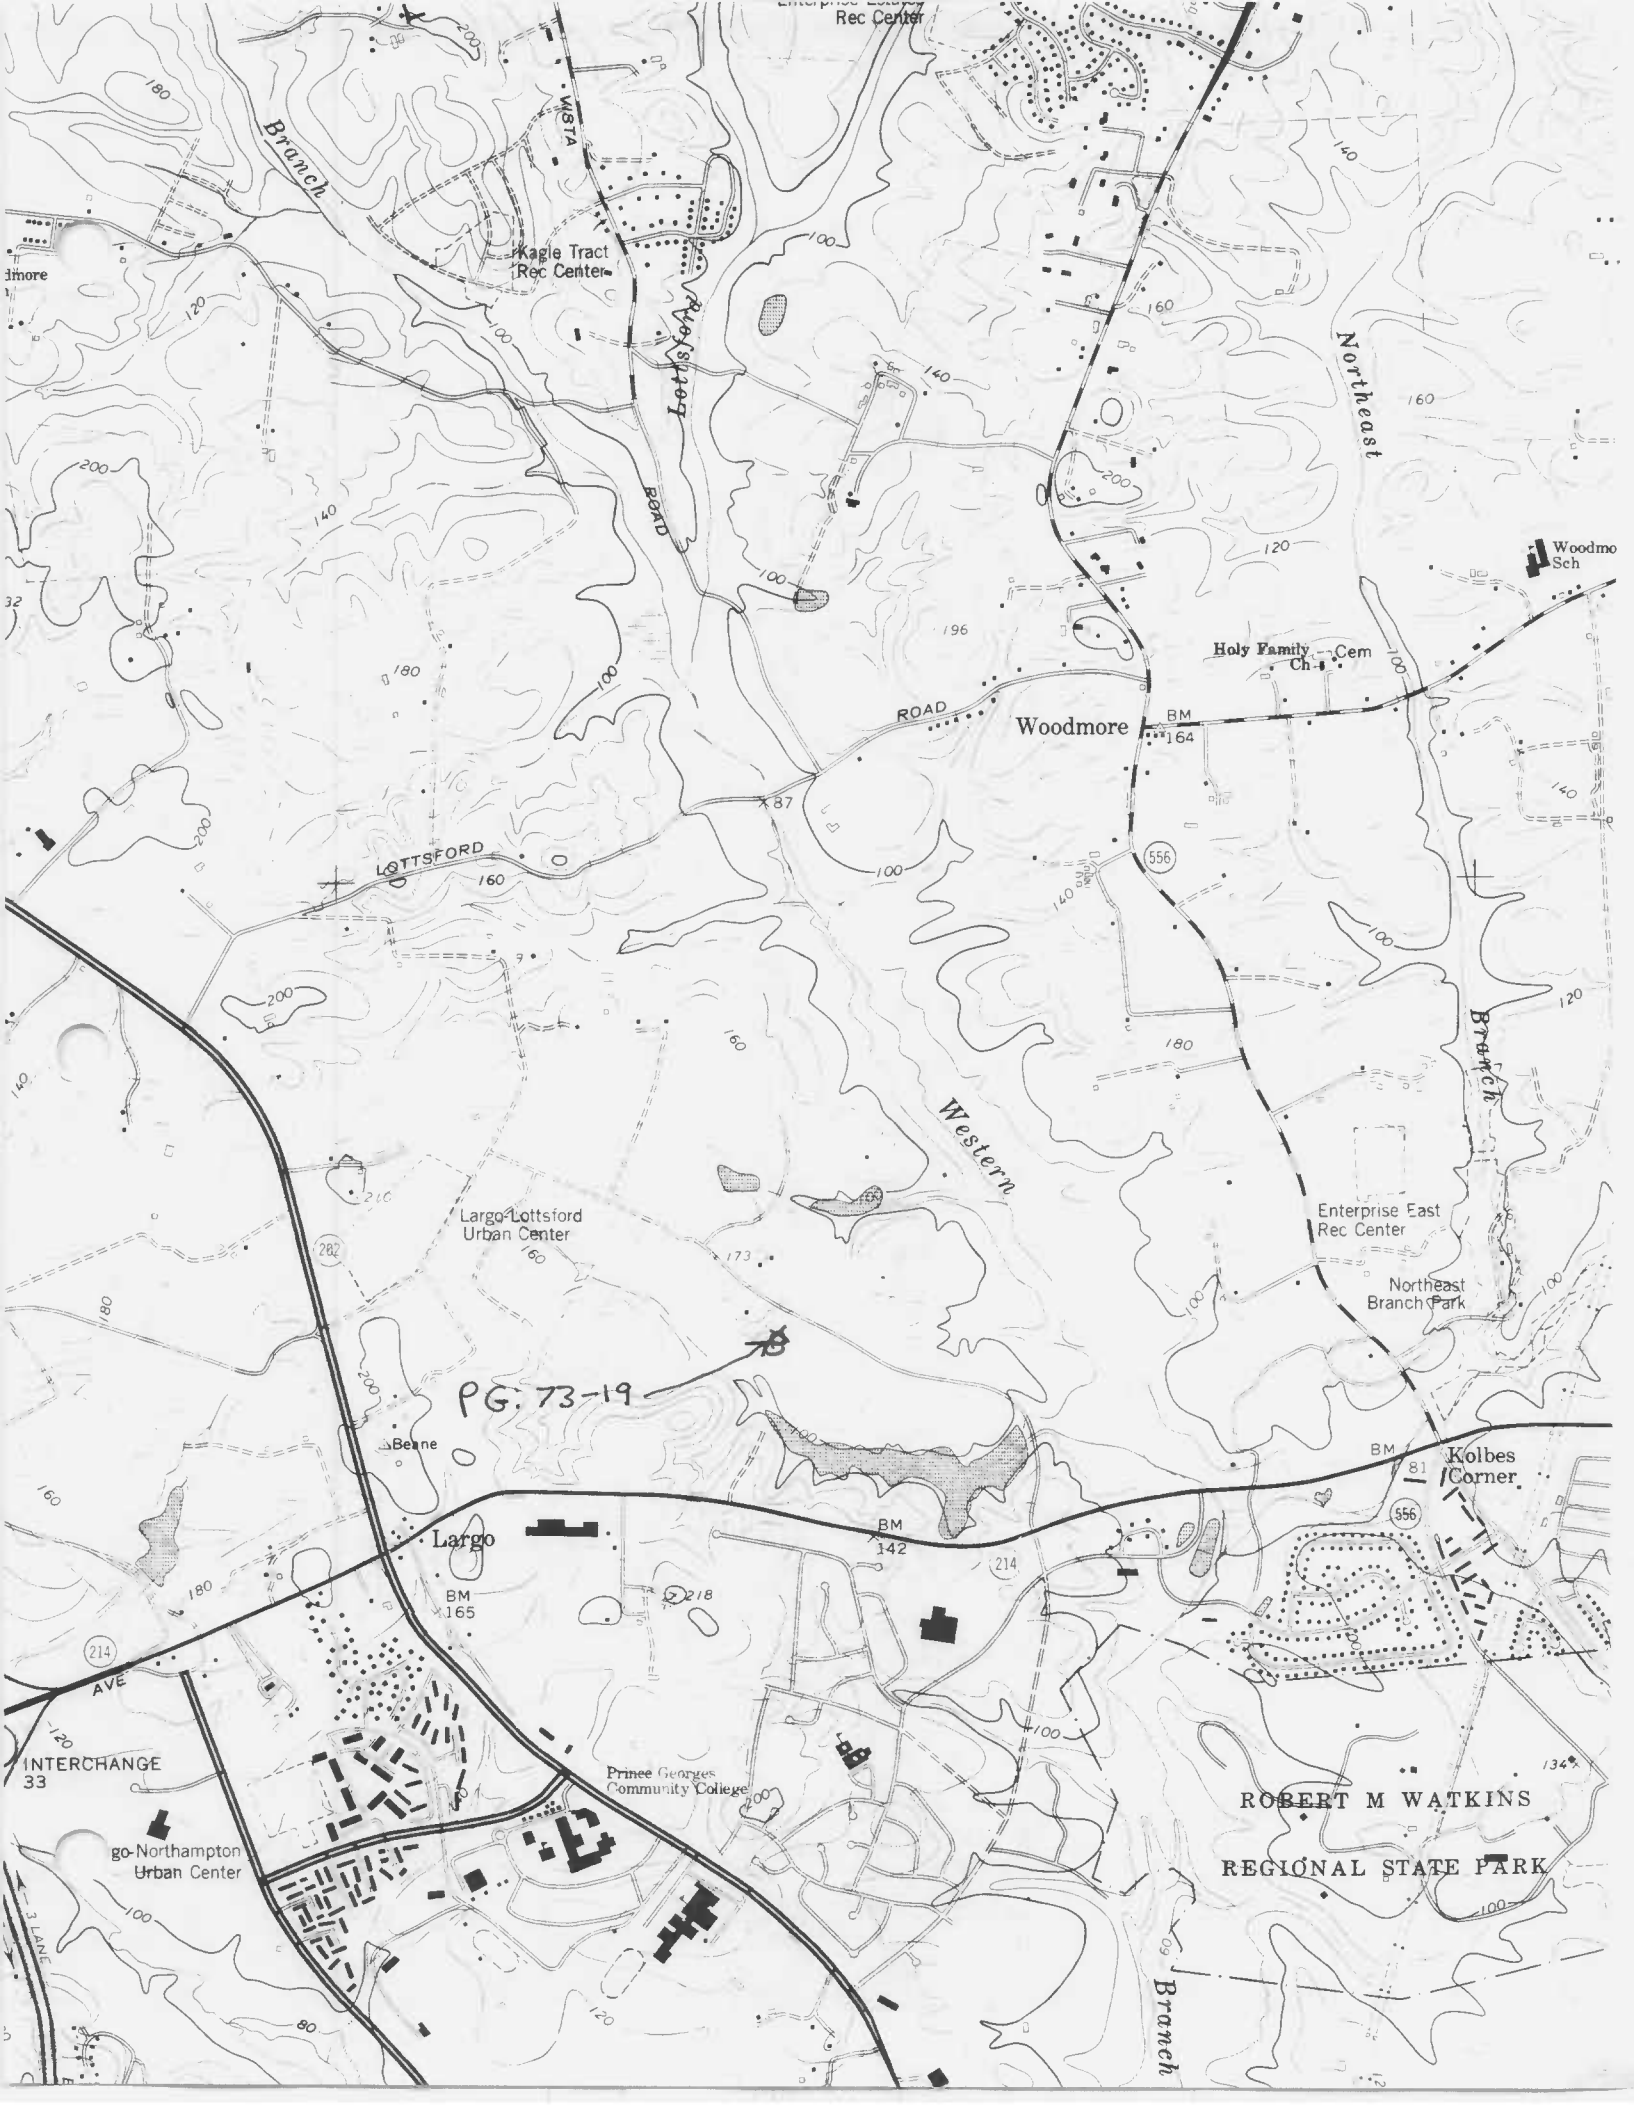
Northampton (Slave Quarters)
Largo, Maryland
VICINITY

The house has no porch; wooden steps with a plain railing lead up to the entrance, with shelves for storing household and farm utensils on either side of the stairs and in the front yard. The structure stands on an exposed foundation of random rubble. The log walls, which can be seen in the original photograph, are sheathed with board and batten. The roof is covered with wood shingles, as was typical of slave houses. A large brick chimney ascends through the middle of the peak of the roof. The windows are small and are closed by wooden shutters, vertically hung. A window of similar size opens through the gable end of the loft. These windows are much smaller than those on frame houses and on later 19th century log dwellings, and indicate the appearance of the more typical slave houses.

This photograph of a slave house is more suggestive than the contemporary ones of the appearance of slave dwellings when they were inhabited and used; the front yard especially is suggestive of this. This structure was not described in the Historic American Buildings Survey records as to its date of construction nor to the number of families who occupied it. It is only designated as a "slave quarters." It is possible that it was built for two families, since it has two separate doorways leading into each room. However, this survey in southern Maryland has found that the more typical arrangement for two family dwellings is for the houses to have two doors placed in the facade.

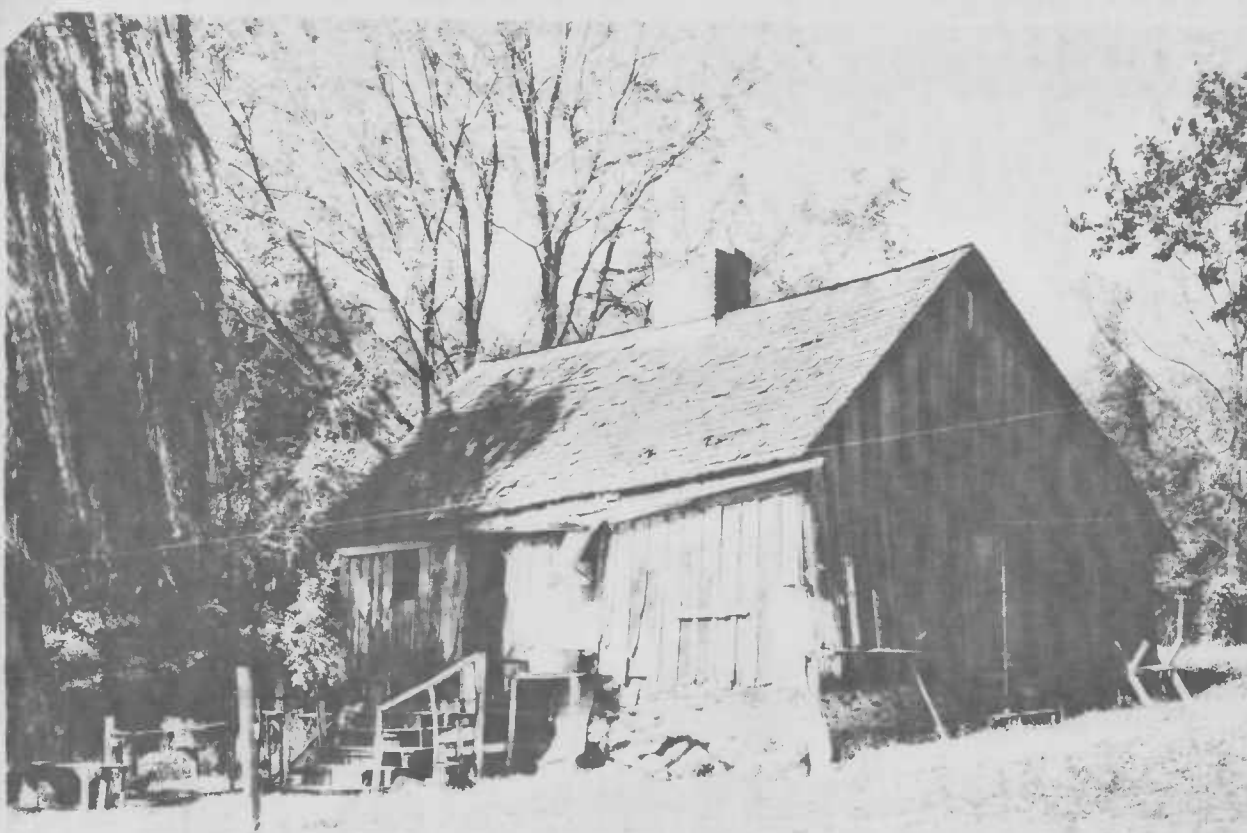
2A-1

The house is one of two slave houses that were photographed by the Historic American Buildings Survey photographer. This one is log, is one story in height, three bays in length, and one in depth. The bays, however, are unevenly divided: the front door is not centered in the length, nor are the windows in their respective bays. The roof also slopes out toward the rear, resembling the form of a roof of a "saltbox" house. *A door is let through the gable end wall.*

VIEW FROM SOUTHEAST (front)
